# Gunlake Quarry Project

**Annual Review**  
**1 July 2019 to 30 June 2020**

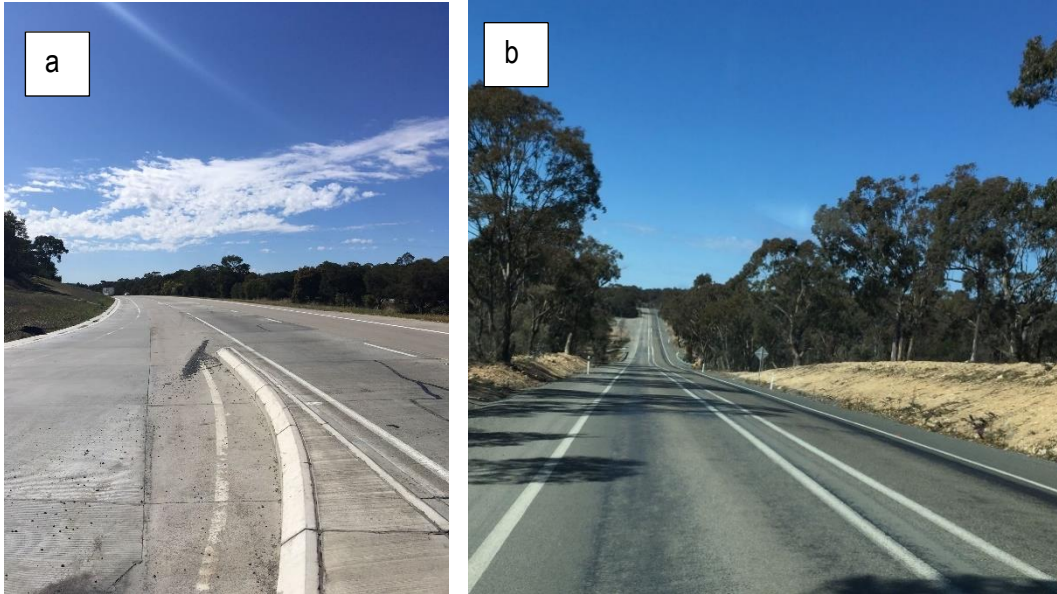
**Plate 1 a) Intersection of Red Hills Road and Hume Highway b) Wide centre line on Brayton Road**

Gunlake has upgraded the Primary Transport Route in accordance with the Austroads design standards, including the addition of the quarry acceleration lane, constructing a new acceleration lane at the junction of Red Hills Road and the Hume Highway to NSW RMS standards, and the incorporation of a wide centre line as shown on Plate 1. This work was completed in the 2018/2019 reporting period.

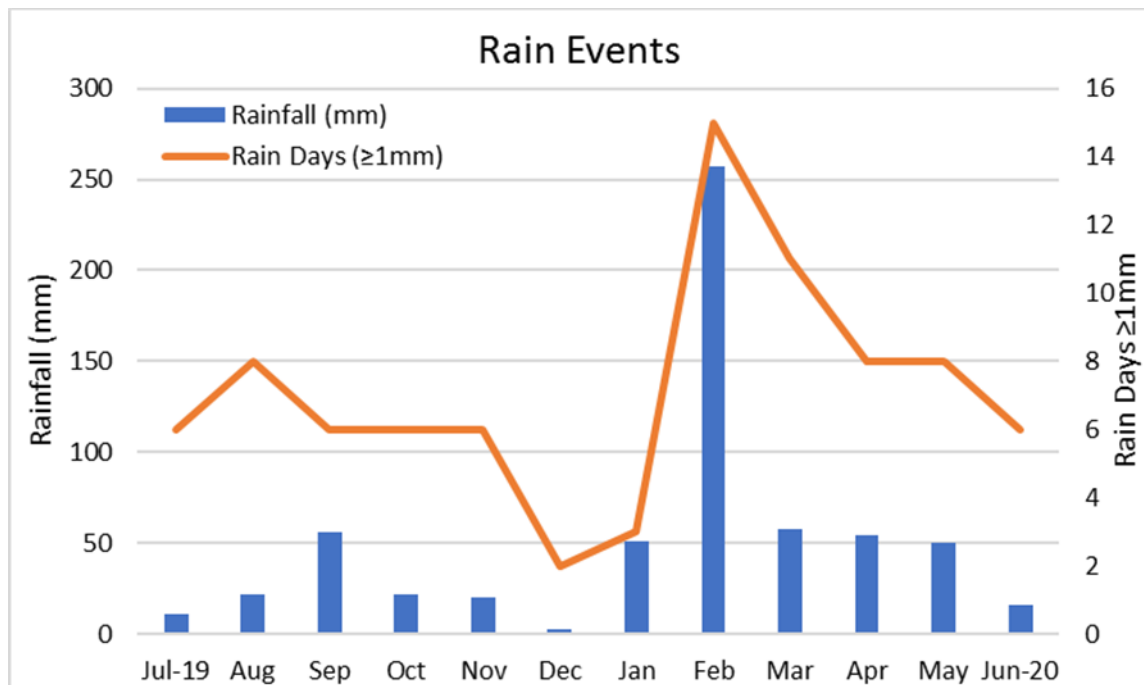
**Graph 6.1 – Monthly Rainfall and Number of Rain Days**

The drought conditions eased slightly during the latter half of the reporting period, following heavy rain in February with a total of 257.2mm and 15 days of rain above 1mm/day for the month (Graph 6.1). The average monthly rainfall was 51.8mm which was reflective of the months September 2019 and January, March, April and May 2020. Meanwhile, December 2019 had the lowest rainfall, with only 2.6mm over the duration of the month.

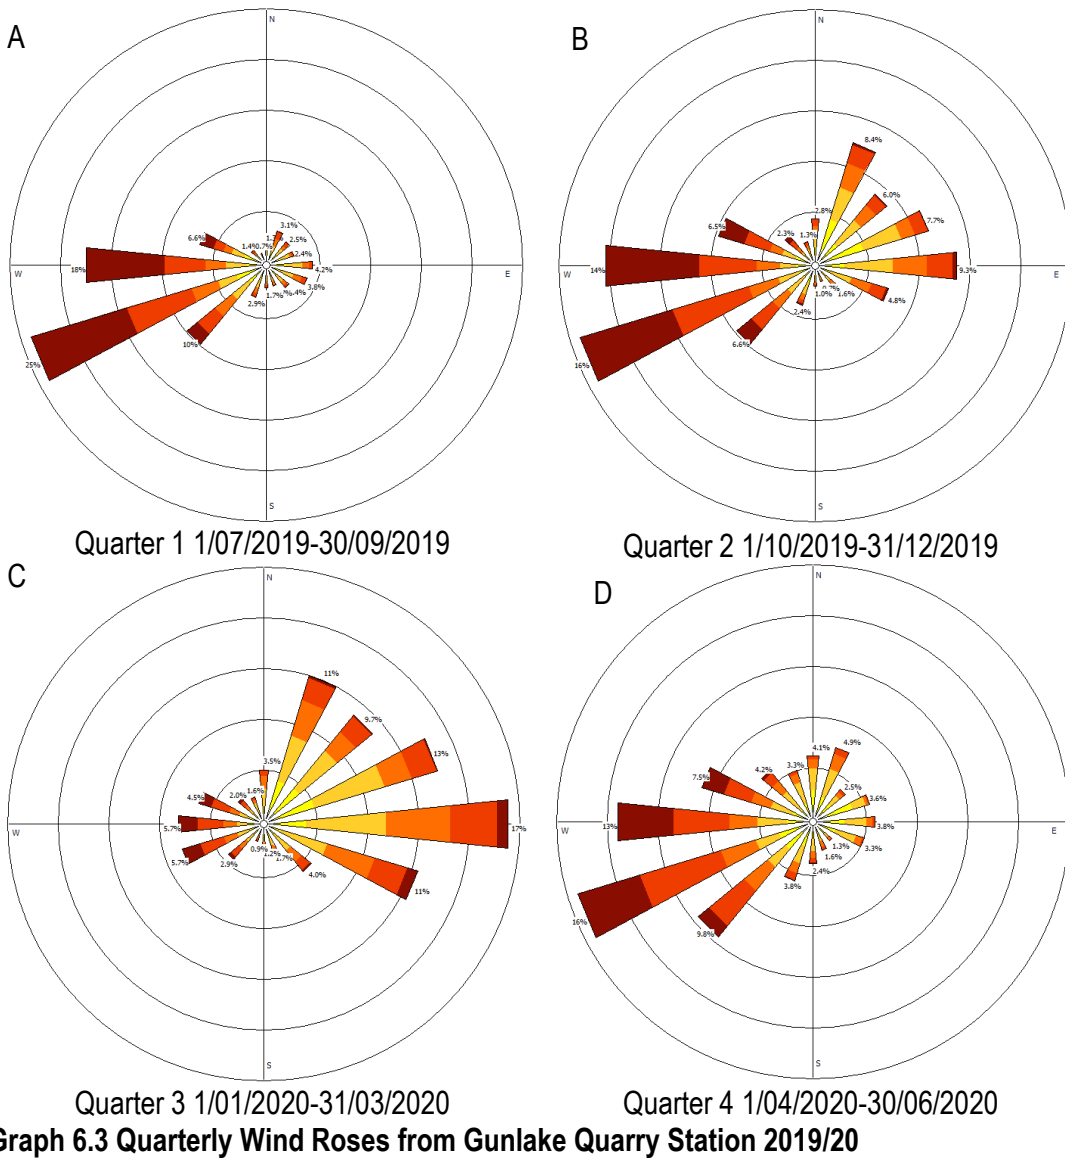
**Graph 6.3 Quarterly Wind Roses from Gunlake Quarry Station 2019/20**

Quarterly wind roses and an annual average wind rose showing wind speed and direction data recorded by the Gunlake weather station are shown in Graph 6.3 (A-D) and Graph 6.4 respectively. The annual recorded wind pattern consists of strong, high speed west-southwest to westerly winds throughout the entire reporting period, however lower speed air flow is predominant from the east-northeast during spring and summer months (Graph 6.3 B, C). The long term average recorded wind speed is 3.5 m/s, and calm conditions remain similar to the previous year with a frequency of (wind speeds less than 0.5 m/s) 10% of the time (Graph 6.4).

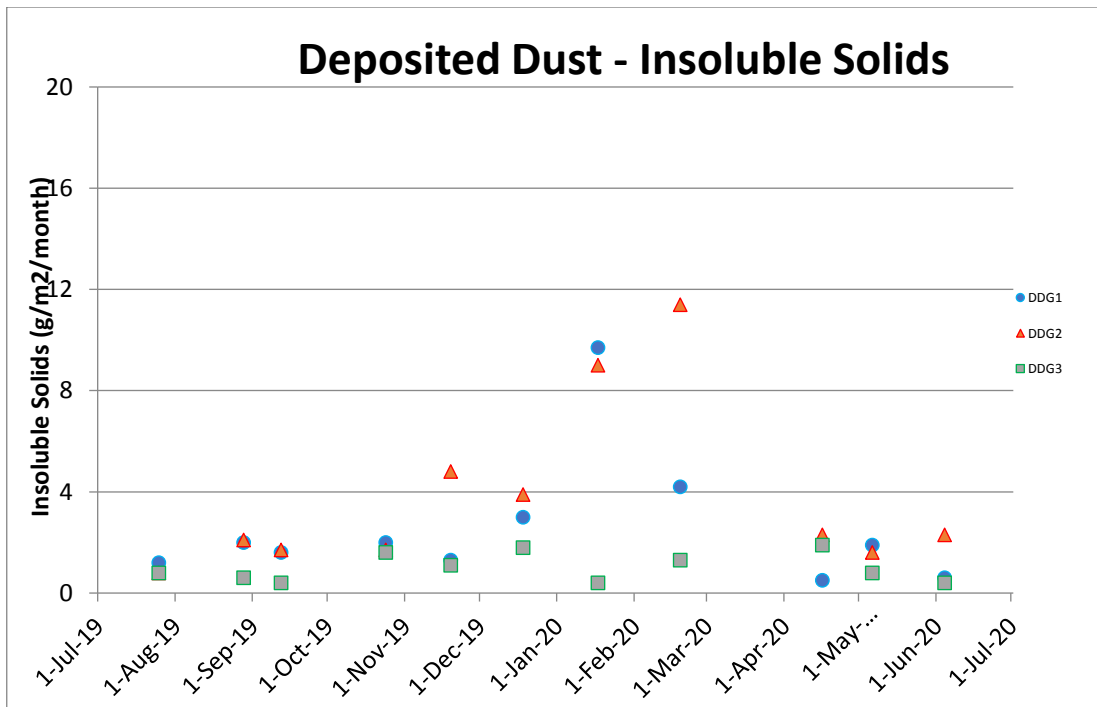
Graph 6.5 - Dust Deposition

The annual average dust deposition at DDG1 for the reporting period was 2.4 g/m<sup>2</sup>/month, which is higher than the background levels and slightly higher than the previous reporting period. It is still, however, below the assessment criteria detailed in the AQMP and Table 6.7.

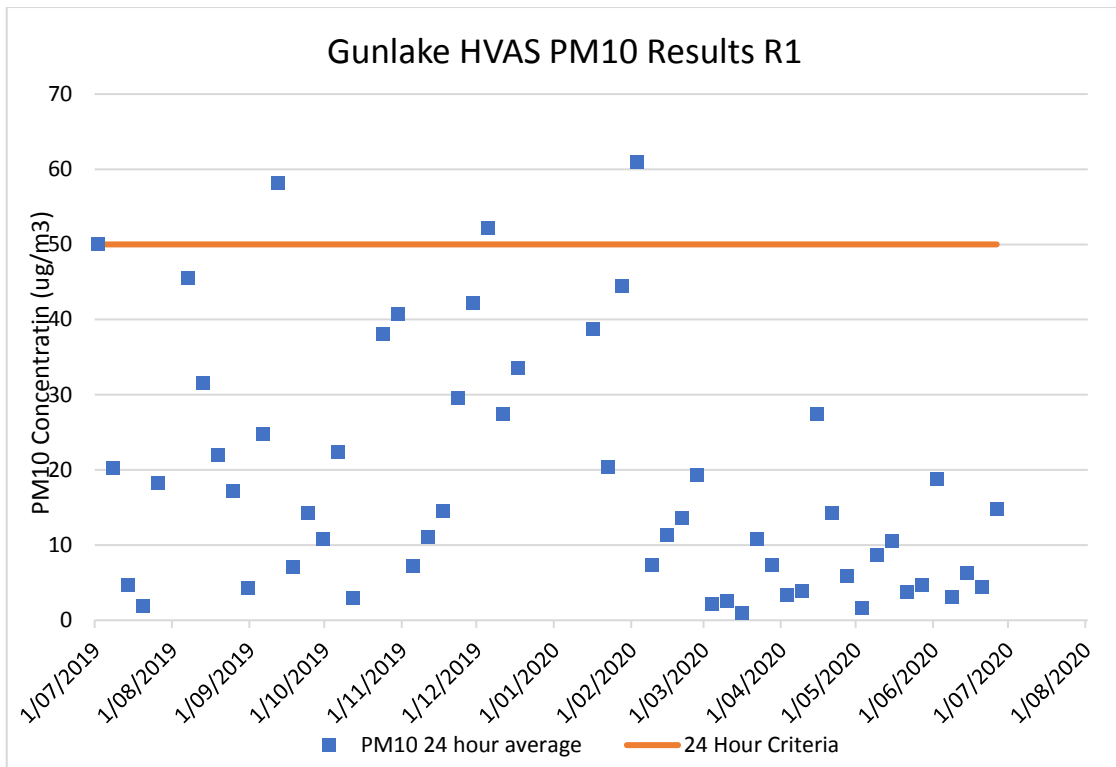
**Graph 6.7 – R1 HVAS PM<sub>10</sub> Results**

The monitoring results at R1, show an annual average PM<sub>10</sub> concentration of 18.63 ug/m<sup>3</sup>, with a maximum 24 hour average of 61 ug/m<sup>3</sup> and a minimum 24 hour average of 1 ug/m<sup>3</sup>. At R4, the annual average PM<sub>10</sub> concentration was 12.80 ug/m<sup>3</sup>, with a maximum 24 hour average of 51.3 ug/m<sup>3</sup> and a minimum 24 hour average of <0.1 ug/m<sup>3</sup>.

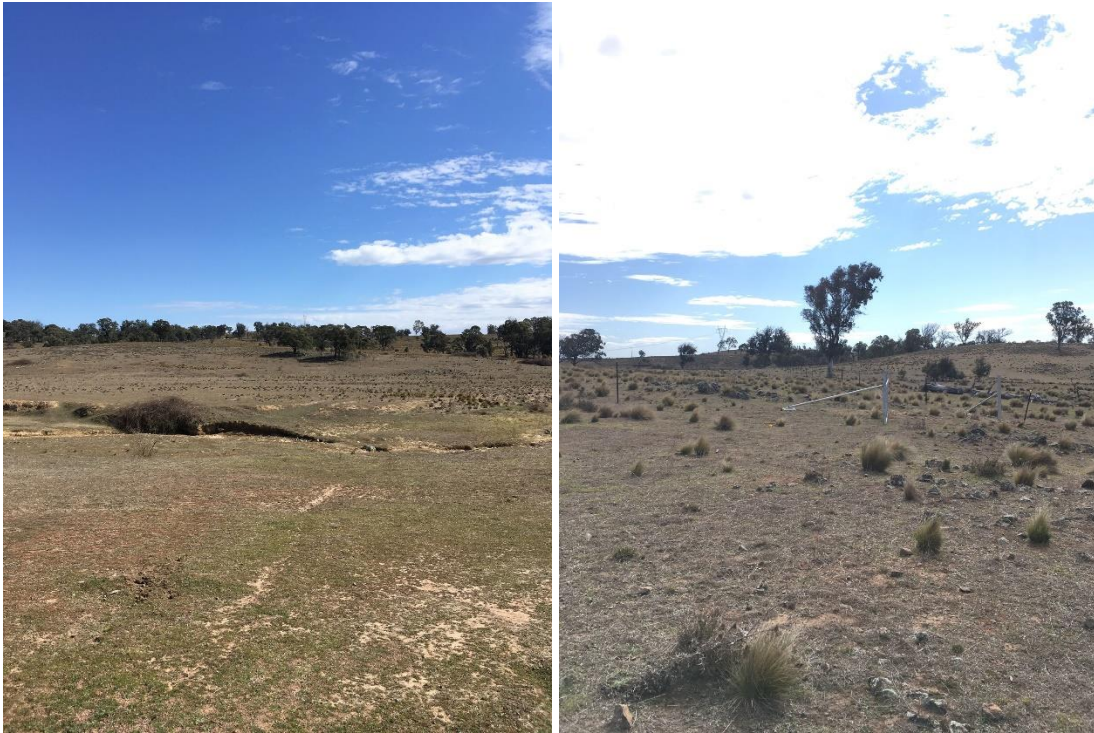
**Plate 5 Gunlake Extension Project Offset Area**

The Biodiversity Areas are currently subject to a modification as detailed in Section 3.2.1. These areas will remain protected under a conservation agreement and managed in accordance with the Biodiversity, Rehabilitation and Offset Management Plan. The Gunlake Extension Project Offset Areas that house the credits will be protected by the BioBanking Agreement. The management initiatives of these areas will be implemented as per the updated Rehabilitation and Biodiversity Offset Management Plan and will be updated with the resolution of the modification.

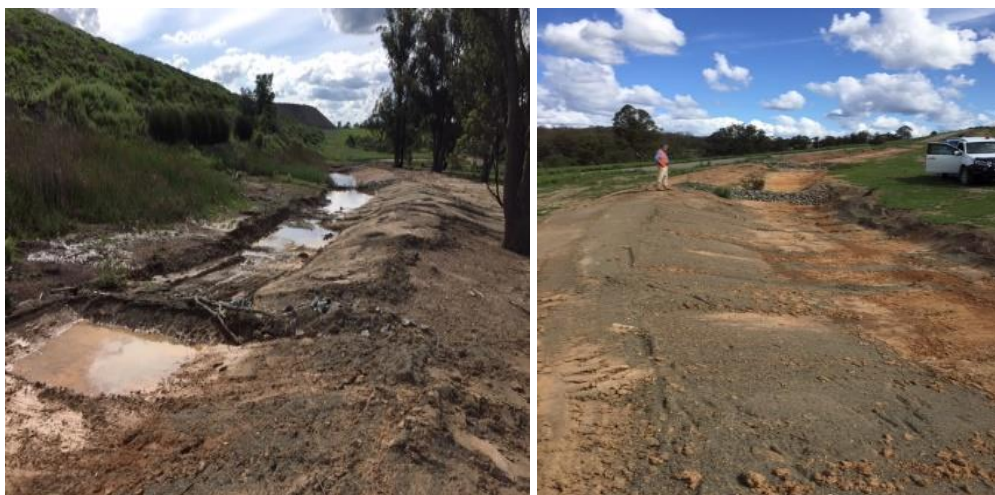
**Plate 6 Maintenance of Bund Wall / Overburden Emplacement Area Drainage System**

The design of the quarry has included the construction of rock-lined drains and check dams, sediment traps and water quality control ponds to contain dirty water. These structures were constructed as part of the initial quarry development and are maintained as necessary in order ensure adequate storage to capture runoff from storm events, to maintain a nil discharge site, and to minimise erosion and sedimentation. The Independent Environmental Audit identified areas of erosion within the stormwater control system below the noise bund emplacement area that required maintenance. This was carried out in March 2020.

The audit also identified the need to desilt the water quality control ponds, particularly the Process Water Dam (PWD). Access to the dam to extract the silt is limited and options to do so are being investigated and implemented. In the interim to prevent further siltation of the PWD, maintenance work was undertaken on the drainage adjacent to the workshop and weigh bridge, and a silt pond installed at the end of the drain directing dirty water into the PWD. This pond is easily accessible and will be cleaned out on a regular basis.

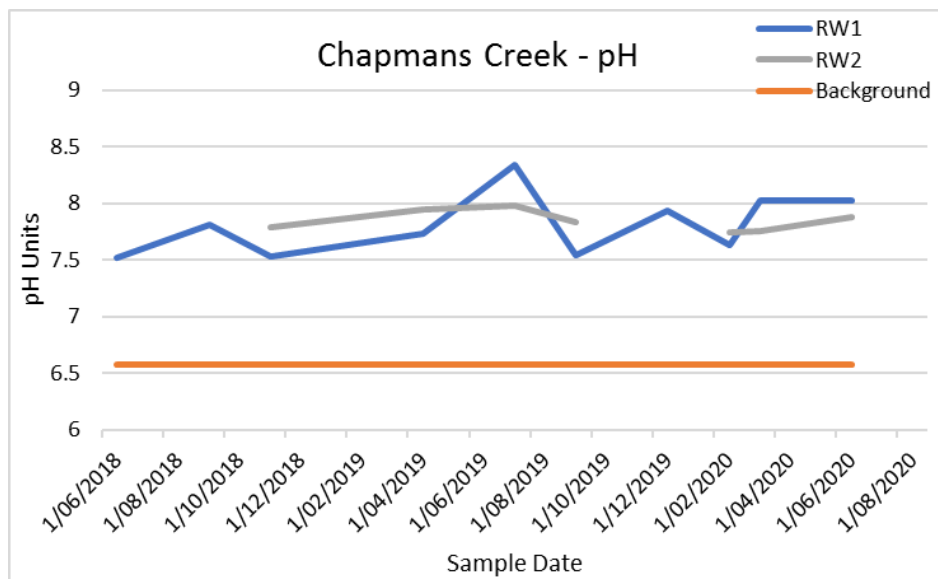
**Graph 7.1 – Chapmans Creek pH**

The monitoring results for the past two periods however show results below the assessment criteria for pH and suspended solids with fluctuating conductivity on a number of occasions exceeding the criteria for both sites in Chapmans Creek. Given the ephemeral nature of the creek it is difficult to determine trends in the water quality and therefore the cause of changes in water quality. The fluctuation in conductivity is likely due to the variation from stagnant water through to high flow events and movement of salts through the system.

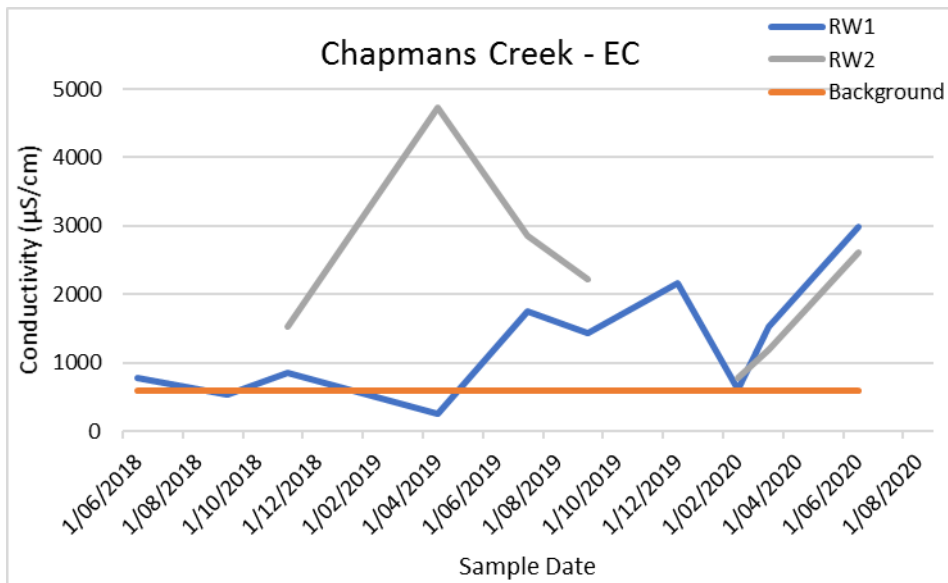
**Graph 7.2 - Chapmans Creek Electrical Conductivity**

The data shows that water quality in Chapmans Creek is largely influenced by groundwater baseflow. Salt levels at RW1 and RW2 respectively average at 1290  $\mu\text{S}/\text{cm}$  and 2278  $\mu\text{S}/\text{cm}$  (Graph 7.2) with a pH slightly above neutral (Graph 7.1). During high flow, the salt content would likely decrease.

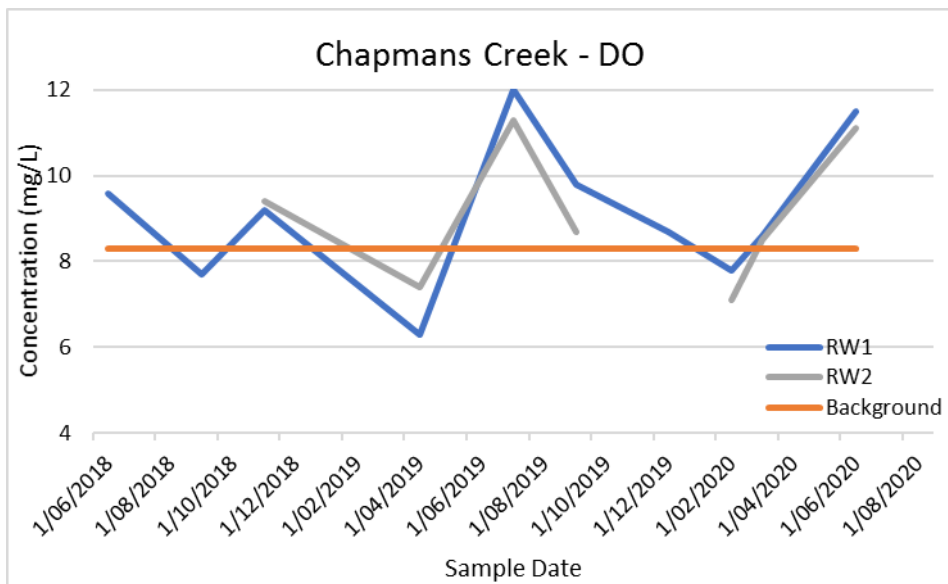
**Graph 7.3 – Chapmans Creek Dissolved Oxygen**

Dissolved oxygen levels presented in Graph 7.3 remain in a range for healthy aquatic biodiversity in line with background levels from the upstream Site I.

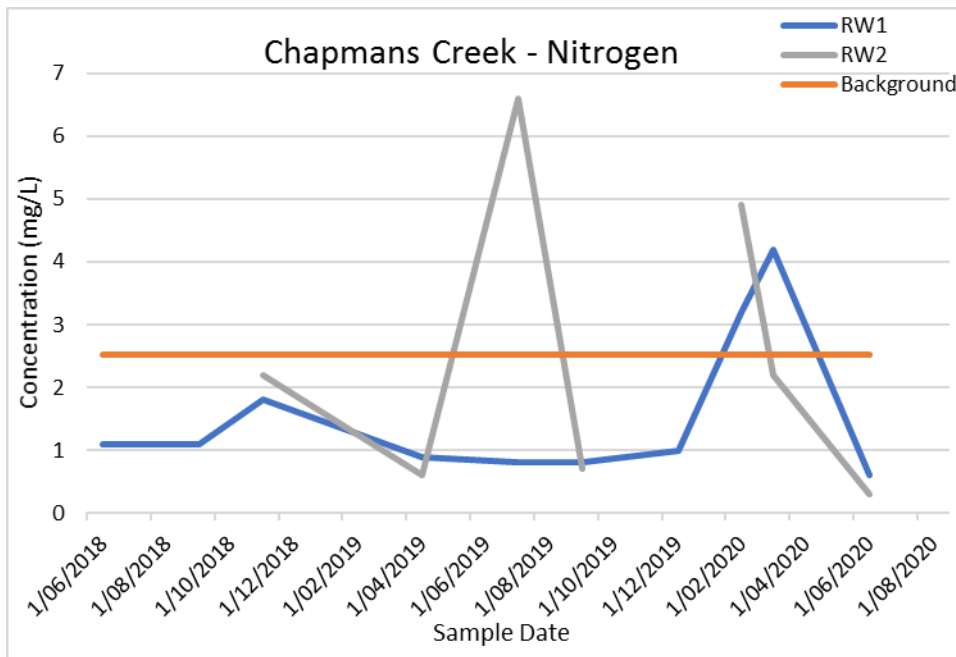
**Graph 7.4 – Chapmans Creek Total Nitrogen**

Levels of total Nitrogen show fluctuation which is likely due to fertilisation of the agricultural properties upstream and downstream of the quarry (Graph 7.4). Total Phosphorous levels shown in Graph 7.5 are consistently below 0.2mg/L and are well below the background average of 0.7mg/L at Site I.

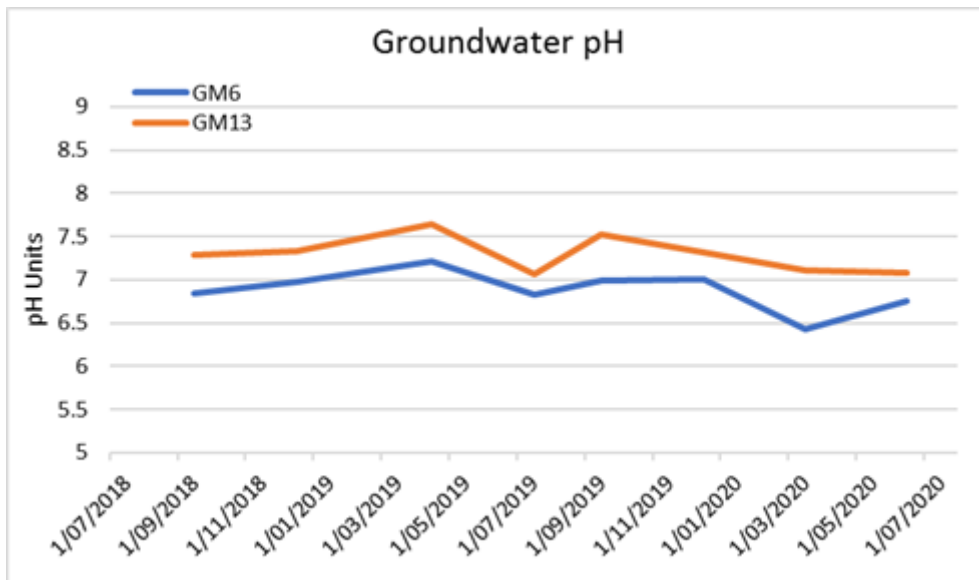
**Graph 7.6 – Monitoring Bore Ground Water - pH**

The monitoring to date shows that the groundwater varies from slightly basic to slightly acidic, having a narrow range of 1pH unit from 6.43 to 7.52 across the sites for the reporting period (Graph 7.6). The lowest pH recorded during the reporting period was 6.43 for GM6 which is slightly lower than the trigger level of 6.5. Subsequent monitoring showed a normal pH range and no further investigation under the trigger action response plan was required. It should be noted that the quarry does not undertake any processes, store or use any materials that would cause a low pH to occur in the groundwater.

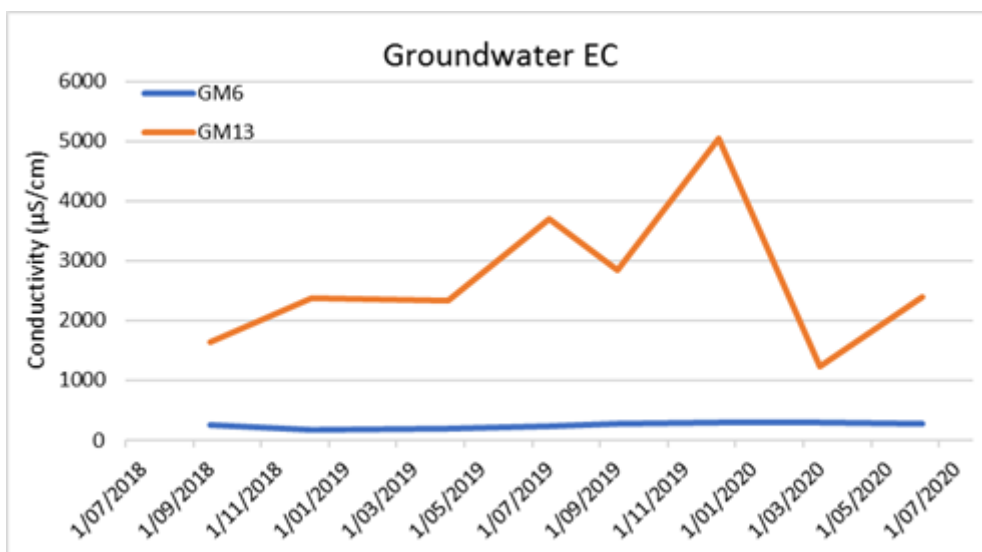
**Graph 7.7 – Monitoring Bore Ground Water - Electrical Conductivity**

The bores show typical groundwater characteristics with conductivity ranging from 280 uS/cm to 294 uS/cm in bore GM6 and 1,230 uS/cm to 5,040 uS/cm for GM13 (Graph 7.7) The concentration of GM6 has remained relatively consistent, although GM13 shows a gradual increase during the prolonged drought conditions, followed by a decline following high levels of rainfall. The concentration in December 2019 exceeds the ANZECC Livestock Drinking Water Guideline which has been adopted as the assessment criteria for groundwater quality. This result however, is not a concern as the levels decline substantially in subsequent monitoring in 2020 following the relief from the drought. The Trigger Action Response Plan as detailed in the Soil and Water Management Plan requires ongoing monitoring if an exceedance of the criteria occurs to establish any trends or correlations to quarrying activities to determine if the quarry is causing the increase in EC.

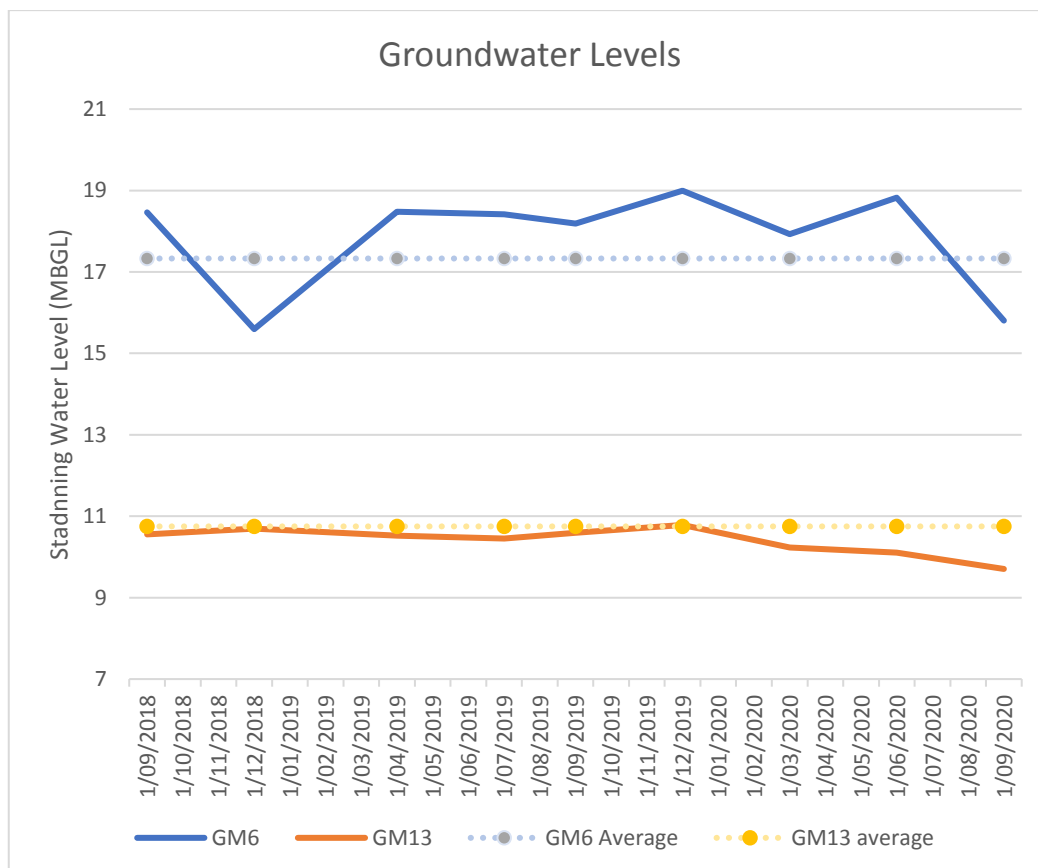
Graph 7.8 - GW6 and GW13 Depth

Bore GW06 remained very stable during the reporting period, with a range from 15.53m to 19.0m below ground level, while GM13 followed a similar but less pronounced trend for the reporting period with an average standing water level of 10.75m and a range of 0.68m (Graph 7.8).

The depth range of these bores can be attributed to recharge of local aquifers following rainfall as can be seen in the slight reduction of depth in February and August 2020. The results indicate that the quarry development is not impacting the standing water level in the bores. The decrease in water level was attributable to the drought conditions but did not fall by more than 20% in either bore and therefore did not trigger further investigations as would have been required by the Trigger Action Response plan. These results are also in line with the EIS predictions. Bore monitoring will continue in the coming reporting period and expansion of the monitoring network with additional bore/s on the western side of the quarry will be examined.

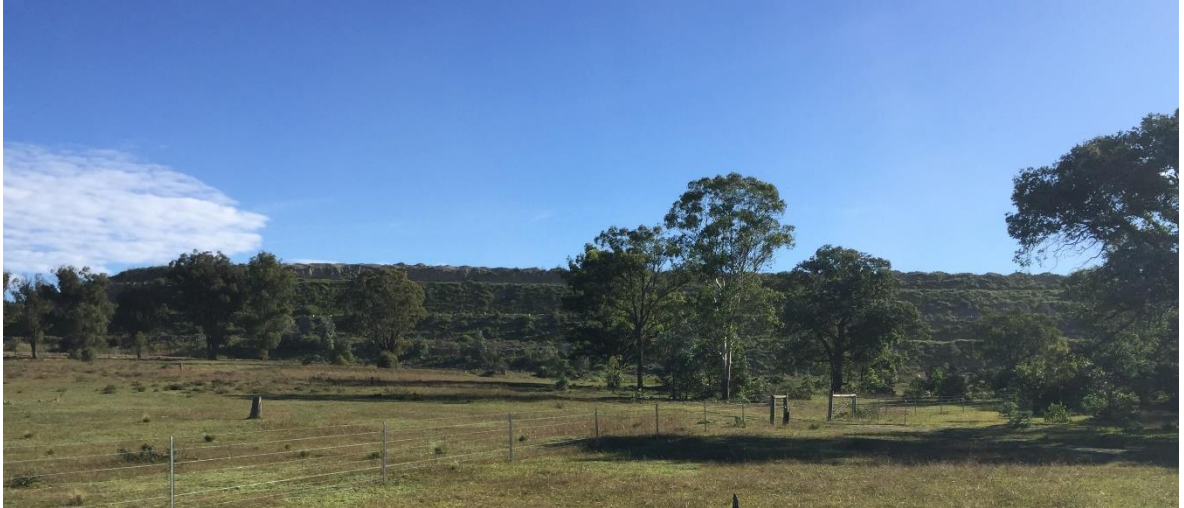
**Plate 9 Rehabilitation of Bund Wall / Overburden Emplacement Area**

The outer extent of the overburden emplacement bund to the north east of the processing area has been shaped and revegetation work undertaken on the completed batters progressively (Plate 9). Maintenance of the rehabilitated area was undertaken during the reporting period, with infill planting of tubestock, weed control and maintenance of water control structures.

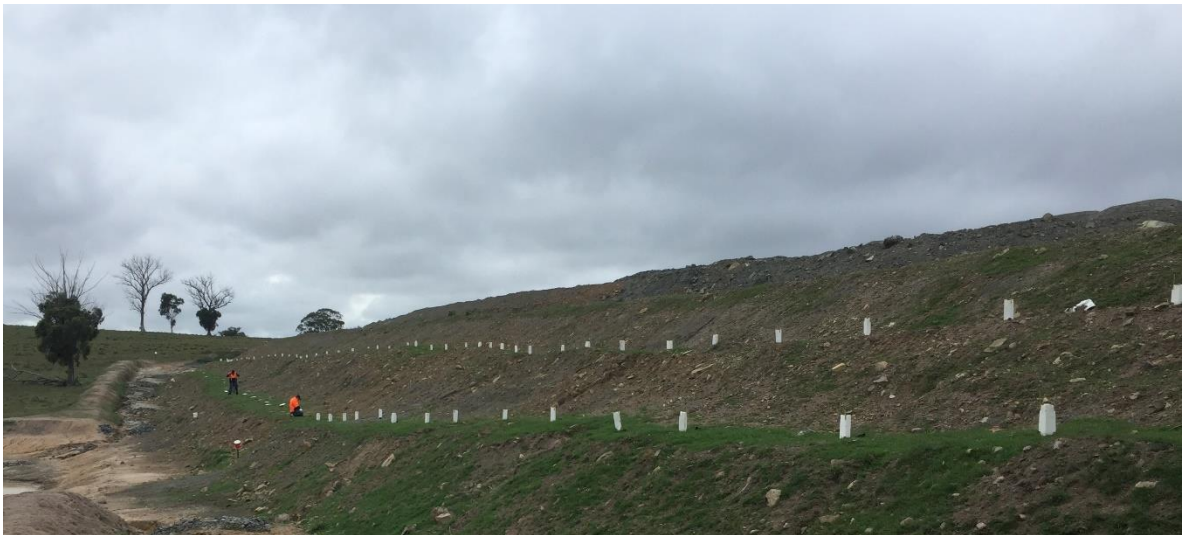
**Plate 10 Rehabilitation of Western Overburden Emplacement Area**

As previously discussed, the drought significantly restricted the rehabilitation activities at the site during the past two reporting periods. Water levels in the drop cut and process water dam were at historic low levels and water was required to be maintained for dust suppression, processing and firefighting, therefore leaving no water for irrigation. Following some rain in February 2020, the first three completed batters at the northern end of the western overburden emplacement area were planted with 600 tubestock to commence rehabilitation of this area (Plate 10).
